Predrag L. Popovic

Senior Principal and Vice President
Wiss, Janney, Elstner Associates, Inc.
Northbrook, Illinois, USA
ppopovic@wje.com

ASSESSMENT AND REPAIR OF EXTERIOR FACADES

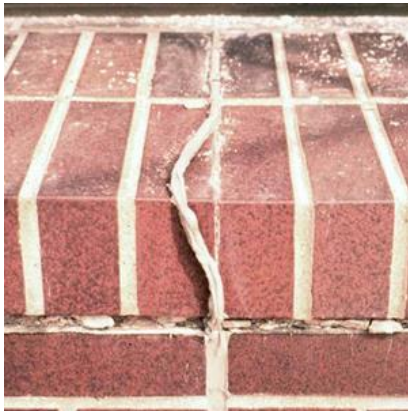
Figure 1. Moisture expansion of brick

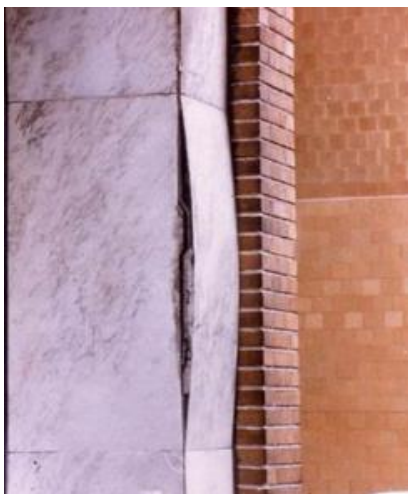
Figure 2. Bowed marble panel due to confined permanent expansion

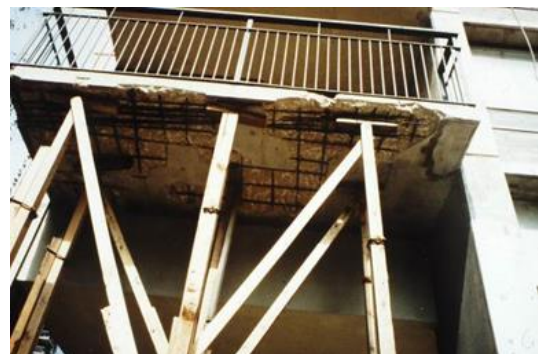
In the course of the investigation and repair, additional safety issues can arise. They can include finding cracks or expensive spalls that indicate structural distress in elements of the facade. That may require installing shoring before proceeding with a repair program (Figure 5).

Figure 5. Severely deteriorated balcony requires shoring

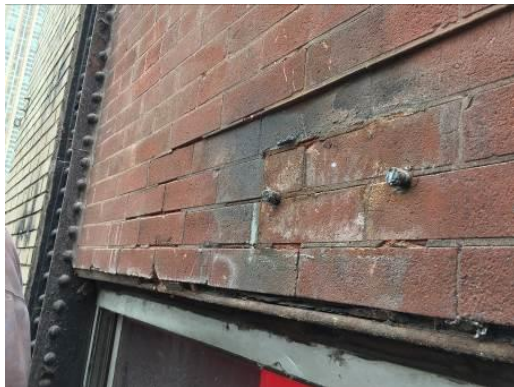
The most common distress observed at the exterior walls clad with brick masonry consists of deteriorated mortar joints; spalled brick and bowed out wall sections due to corrosion of embedded steel shelf angles and steel window and door lintels (Figure 6); cracks observed at building corners, and sections of walls that cannot accommodate movements; displaced wall sections due to inadequate or missing anchorage to the backing wall; deteriorated sealant in expansion joints; soiled walls; freeze-thaw damaged brick and deteriorated bricks due to applied unbreathable paint coatings over them.

Figure 6. Distressed section of brick masonry wall before and after removal of brick to expose corroded embedded steel lintel

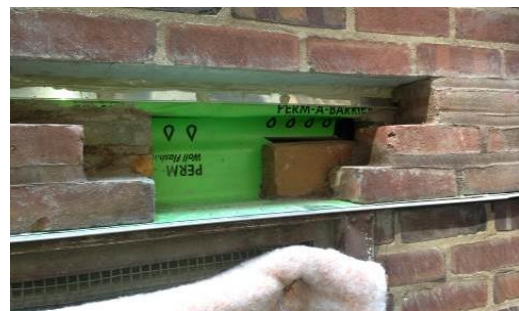
Figure 7. Repaired steel lintel with installed flashing over it

Repointing of mortar joints: includes grinding out deteriorated or cracked mortar joints, and installation of new mortar in order to prevent water infiltration into the building; replacement of damaged brick with new; installation of repair anchors to stabilize/secure the movement of displaced section of the brick wall; and repair/replacement of shelf angle/lintel includes removal of brick above the shelf angle/lintel as needed to expose the corroded portion of the embedded steel and repair/replace it based on percentage of section loss (Figure 7).

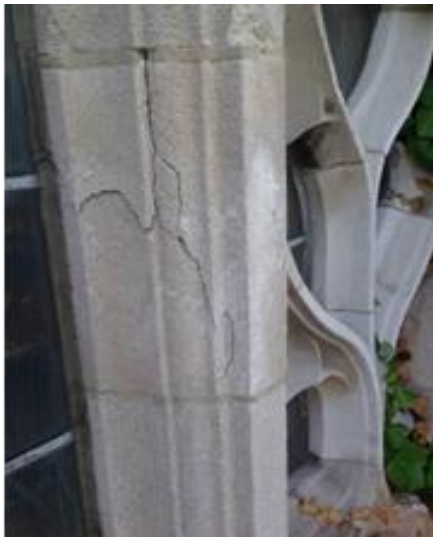
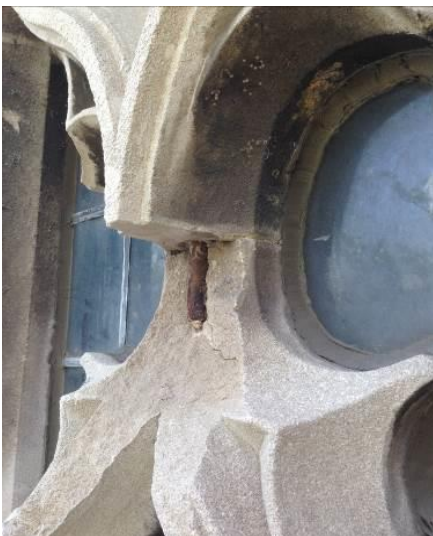
Figure 8. Cracked and spalled window mullions and rosettes

At locations of displaced and cracked limestone panels steel lintels, dowels and straps behind them were severely corroded. The expansion of corrosion build-up creates large expansion forces causing pressure on adjacent stone, which caused displacement and cracking of the limestone blocks at their back portion. Typical observed distress is shown in Figures 8 and 9.

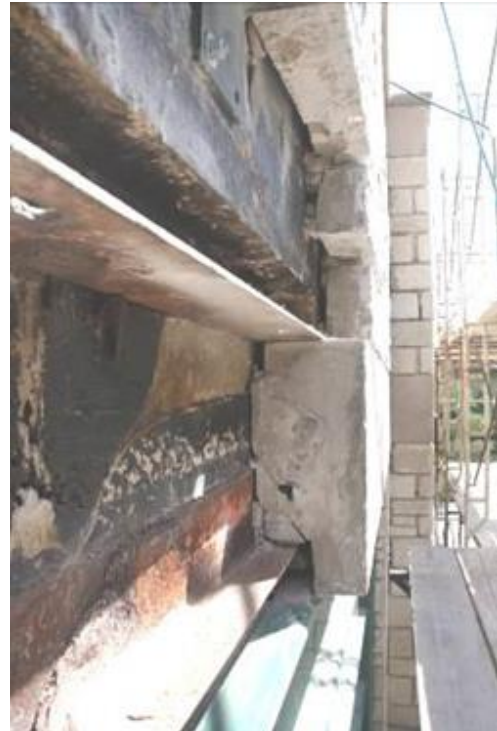
Figure 9. Severely corroded steel shelf angle and cracked and spalled limestone block due to corrosion

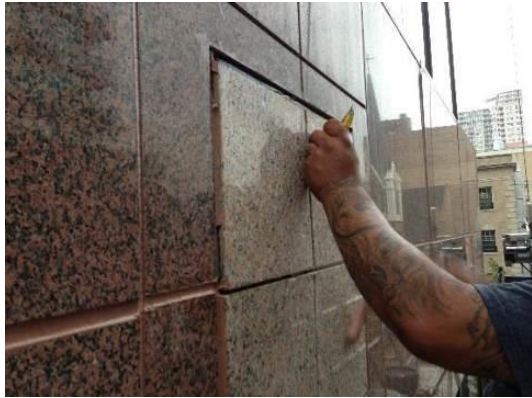
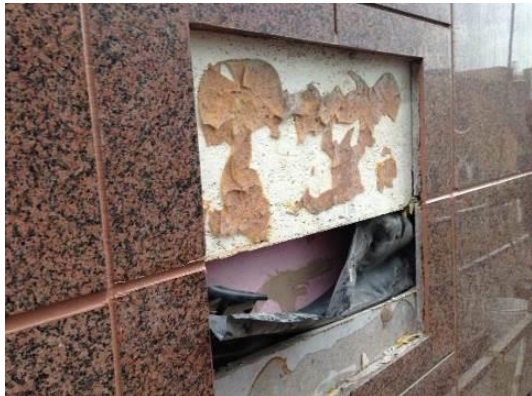
In case where epoxy was used as an attachment adhesive, it was discovered that granite inserts embedded into granite panels were debonded from the backing material, as shown in Figure 10.

Figure 10. Granite inserts attached with epoxy adhesive that has failed

Other repairs included replacement of deteriorated sealant in joints between stone panels; replacement of inadequate connections at granite panels included installation of new stainless steel angles anchored into the backing wall and reattaching granite panels to them; and reattaching of granite inserts using epoxy adhesives included removal of existing failed adhesives and backing material and installation of new.

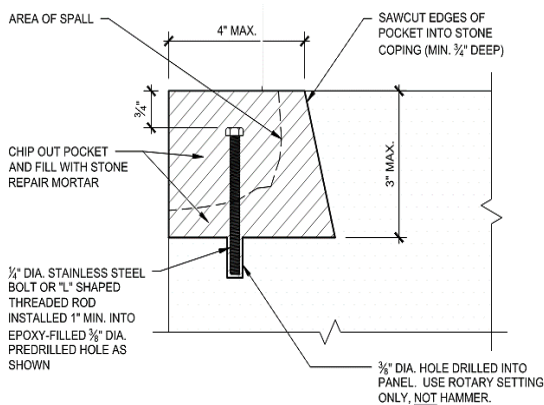
Figure 11. Limestone patch

Repointing of mortar joints includes grinding out deteriorated or cracked mortar joints and installation of new mortar; patching of spalled limestone with a hand-placed mortar patch, as shown in Figure 11.

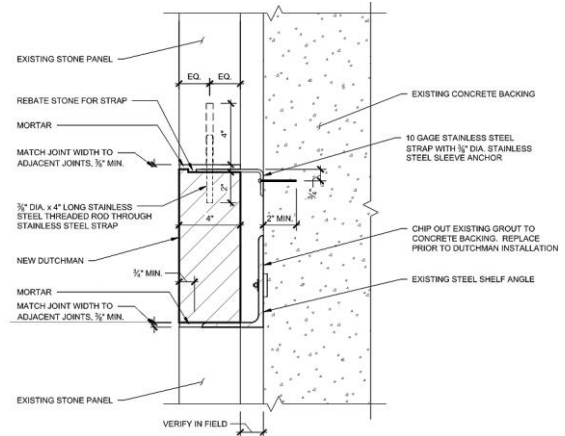
Figure 12. Dutchman limestone repair

Dutchman repair includes removal of sections of deteriorated or damaged limestone and repairing the removed area with limestone dutchman held in place with strap anchors and/or stainless steel pins, as shown in Figure 12.

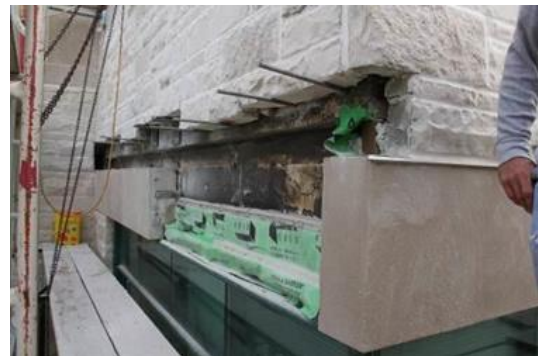
Figure 13. Repair of steel shelf angle/window lintel

Repair option also included replacement of damaged limestone with new; installation of repair anchor to stabilize/secure the movement of displaced stones; repair of shelf angle/lintel. Based on the percentage of section loss it is determined is shelf angle/steel lintel would be repaired or replaced; installation of flashing with a drip edge over steel lintels (Figure 13).

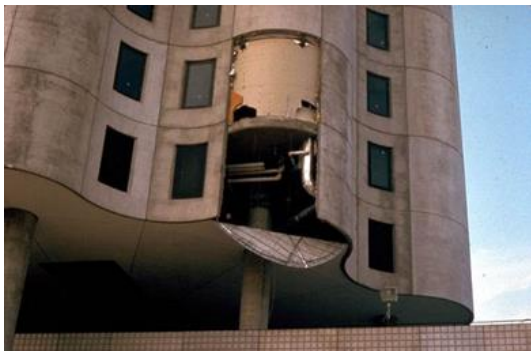
load transfer, creep, shrinkage and thermal movement of the facade elements and the structural frame, but also for field variation in connection location and alignment. The installers of the panels often try to overcome these alignment difficulties by adding supplemental shims or by field welding or bolting supplemental connection plates to make up for poorly matched connectors. However, these field installed connectors do not perform well because the field installers do not fully understand the design and implications of varying the connection. In some instances these failures can be catastrophic as shown in Figure 14.

Figure 14. Failure of facade panel connection

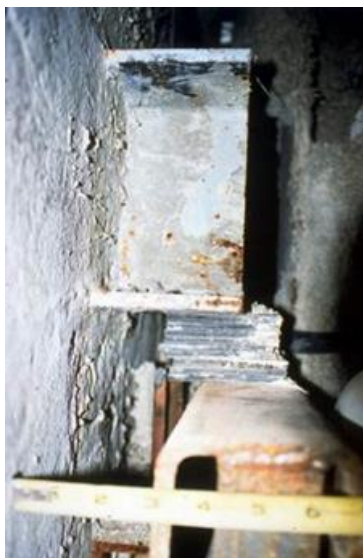
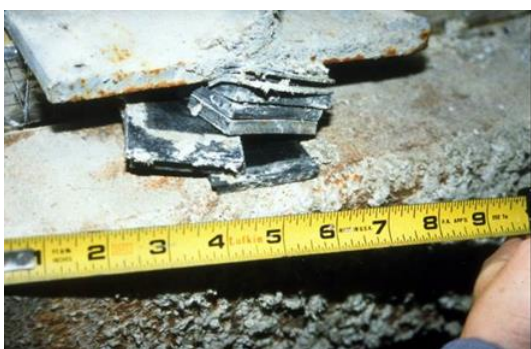
Figure 15. Inadequate bearing of façade panels

The most often observed cause of exterior facade panel failures was the improper construction of panel connections to the building frame. Construction deficiencies included using the originally designed connections for connecting the panel to the building frame even though the frame connections were not located at the intended elevation and location; improper placement of the connection plates, bolts or welds; misalignment of panel; using erection shims and bolts as permanent connection as shown Figure 15; and welding connection plates when they were intended to be bolted to allow for volume changes. Most of these problems could have been easily and inexpensively solved if the erector, after realizing that the connections did not fit the as-built frame, would have alerted the design engineer or had his own engineer modify the connections with due consideration to the forces and the actual dimensions involved.

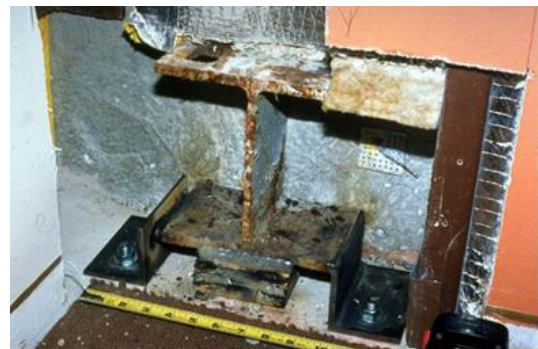
Figure 16. Typical gravity load connection repair

The retrofit design for typical gravity connection included welding fairly thin steel plates on each side of the haunch flange and to the steel bearing plate, as shown in Figure 16. This connection provided transfer of gravity load, restrained out-of-plane movement of the panel, and allowed for the volume change movements along the length of the panel through flexibility of thin steel plates. The interesting aspect of this repair project was that the repairs had to be performed without interruption of the hospital operations. Up to three patient rooms were emptied each day, the inspection openings

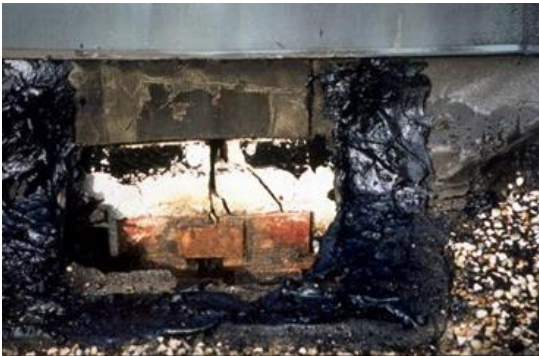
Another example of improperly built connections were the supports for 10 m high facade panels of a four-story police/jail facility. These very heavy panels had the type of the panel built as a haunch which rested on the roof slab of the building. Unfortunately, all the panels were rigidly connected to each other by steel connection plats welded to adjacent supports. This prevented normal volume change movements and caused all panels to crack at and around their bearing supports (Figure 17). The repair included attaching supplemental steel brackets to the panels away from the original supports and transferring through them the weight of the panels to the roof (Figure 18).

Figure 17. Cracking of panel bearing

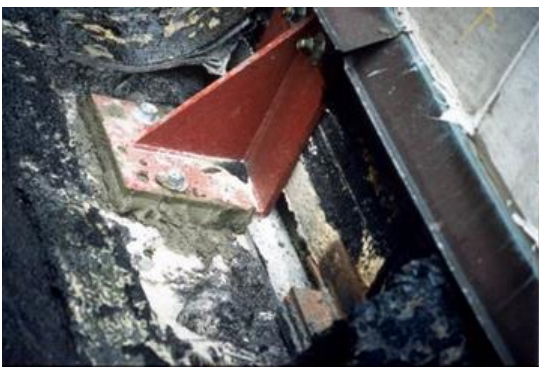
Figure 18. Connection retrofit with steel bracket

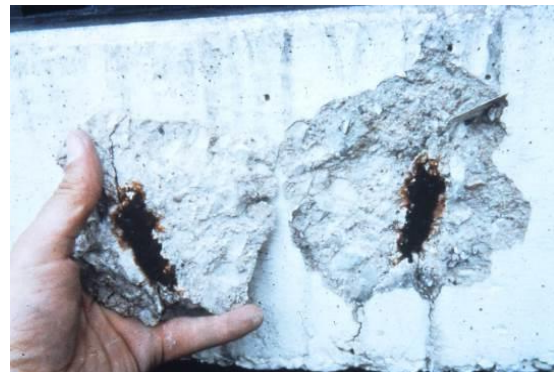
Inadequate concrete cover over the reinforcing bars can result in moisture from the rain penetrating to the steel rebars which will begin to corrode. Expansion forces of the corrosion by-product (rust) will result in cracking and spalling of concrete (Figures 19 and 20). Standard concrete repair techniques include

Figure 19. Spalling and cracking of the concrete façade

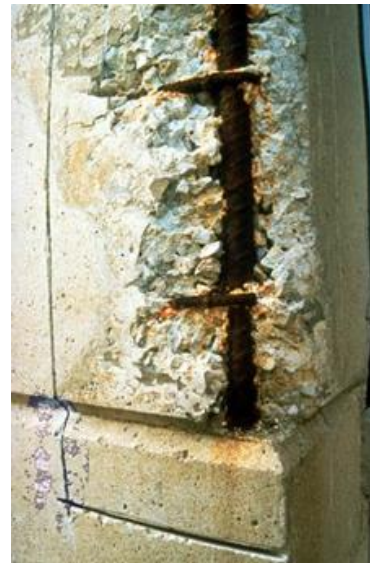
Figure 20. Spalling and cracking of the concrete façade

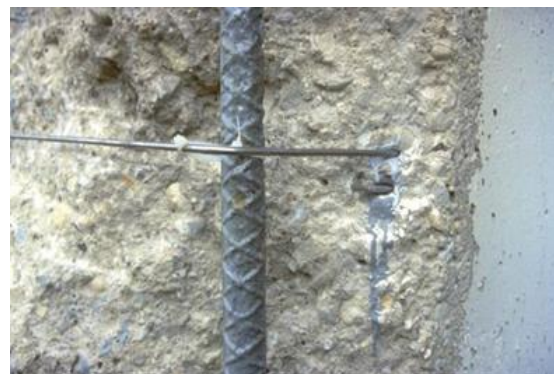
Figure 21. Facade patch repair

chipping deteriorated concrete around corroded rebar, sandblasting rebar and concrete surfaces, epoxy painting the rebar and pouring or hand applying concrete patches. It is recommended to install stainless steel wire anchored in the concrete substrate to help hold the patch in place if the bond between the substrate and patch weakens (Figure 21). Similar repairs are used for exposed slab edges.

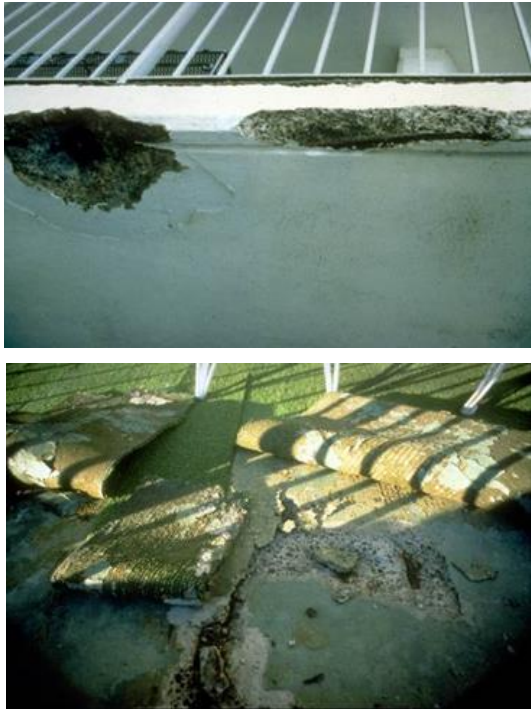
Concrete balcony slabs usually have additional deterioration due to the presence of steel railing posts embedded in the concrete slab. The deterioration of balcony slabs is accelerated if there is carpet present on the balcony (Figure 22). Painting the repaired facade with a breathable acrylic paint will improve the appearance and durability of the repair.

Figure 22. Deterioration of concrete balcony

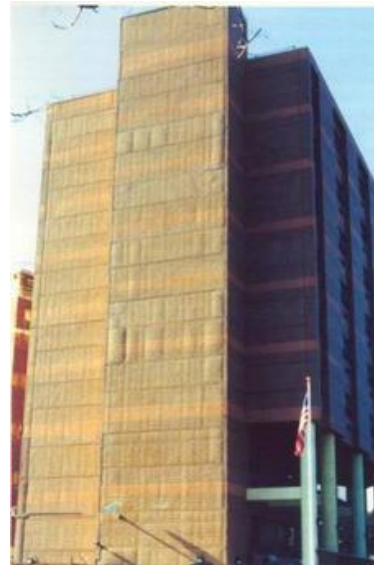
Outward bowing on thin brick bonded to cement board is shown in Figure 23. Connections of thinner marble and granite façade panels to the

Figure 23. Outward bowing of thin brick bonded to cement board

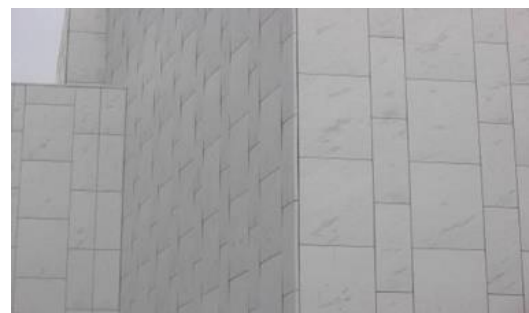
structural system of the building had smaller safety factors and cracks were occurring in the stone at locations of the connections. Bowing of marble panels is shown in Figure 24.

Figure 24. Bowing of new marble panels on Finlandia Hall, 2005

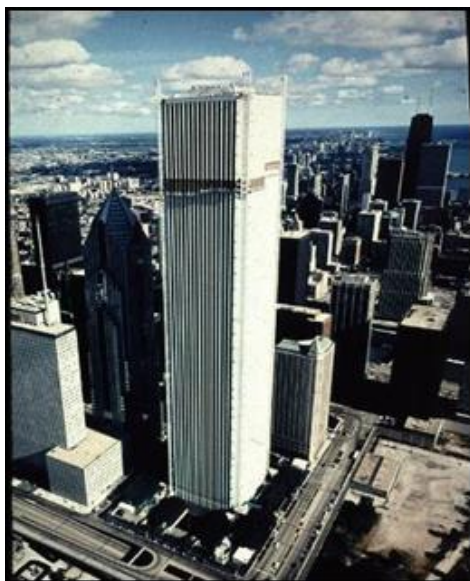
Figure 25. Recladding of the 82-story tall marble clad Amoco building

These conditions required removal of the existing cladding, and the design and installation of the completely new different façade system. The new system and connections should be tested with mock-ups before proceeding with the project. Figure 31

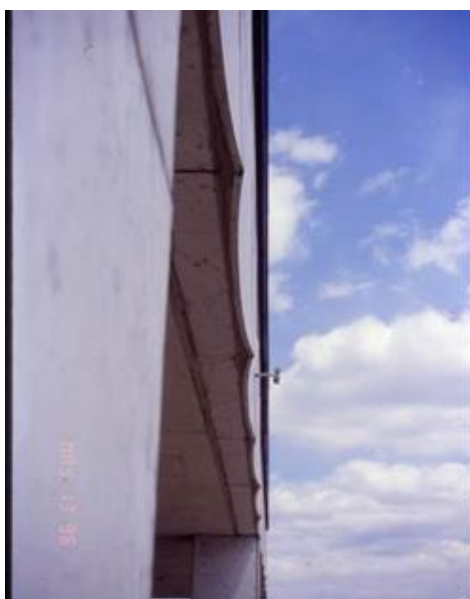
As the facades with thin marble panels were beginning to age, bowing of the panels as shown in Figures 25 and 26, and failure of their connections were observed. Loss of flexural strength due to exposure to heat from the weather became evident. While this loss of strength was not affecting the performance of the thicker marble panels in the past, now with thin marble panels it became a major factor in their performance. It also became evident that details and connections for the panels that worked well in the past with thicker panels needed to be revised to accommodate the behavior of the thinner stone panels.

Figure 26. Bowing of panels
