STRUCTURAL VIBRATION MEASUREMENT IN DAM MONITORING

1.1. HYDRAULIC POWER PLANT BREŽICE

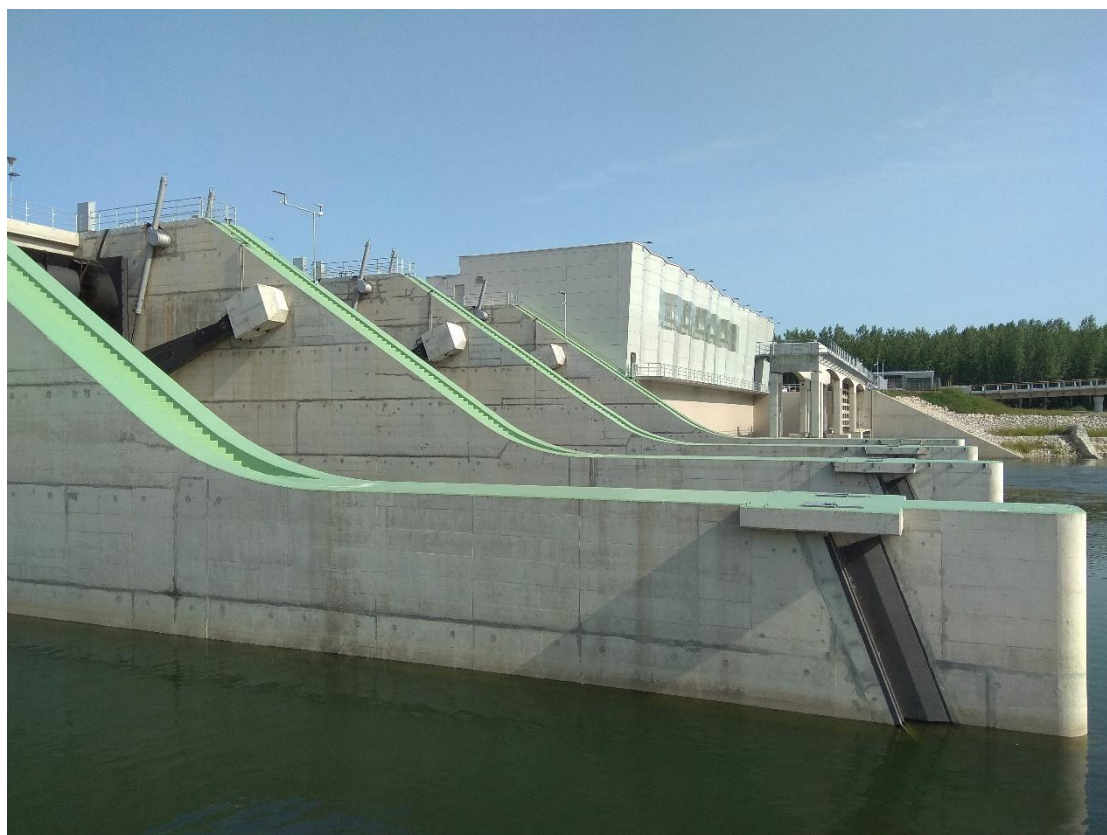
Brežice HPP (Fig. 1) is a fifth hydro power plant in the chain of six hydropower plans on the Lower Sava River. It is a run-of-river type of power plant with a limited storage capacity, which will enable partial compensation of the discharge once the hydro scheme on Sava will be finished. The dam is a combined type of dam; the central concrete-gravity part of dam consists of powerhouse and five overflow sections. The two earthen embankments with maximum height of 9.5 m are connecting the riverbanks to the 160 m long concrete part. Structural height of cross-section of the concrete dam varies, maximum structural height is 36.5 m in the cross section of the powerhouse, and spillway section reaches maximum height at 16 m respectively. The spillway section consists of five 15 m wide overflow sections, each with a maximum discharge capacity of 1,000 m³/s. Each spillway is installed with a segment gate with a flap for fine level regulation [1].

Figure 1: HPP Brežice

In the power station three vertical Kaplan turbines with a design rated power of 45 MW

are installed with estimated annual production of 161 GWh. Rated flow rate is to be 500 m³/s

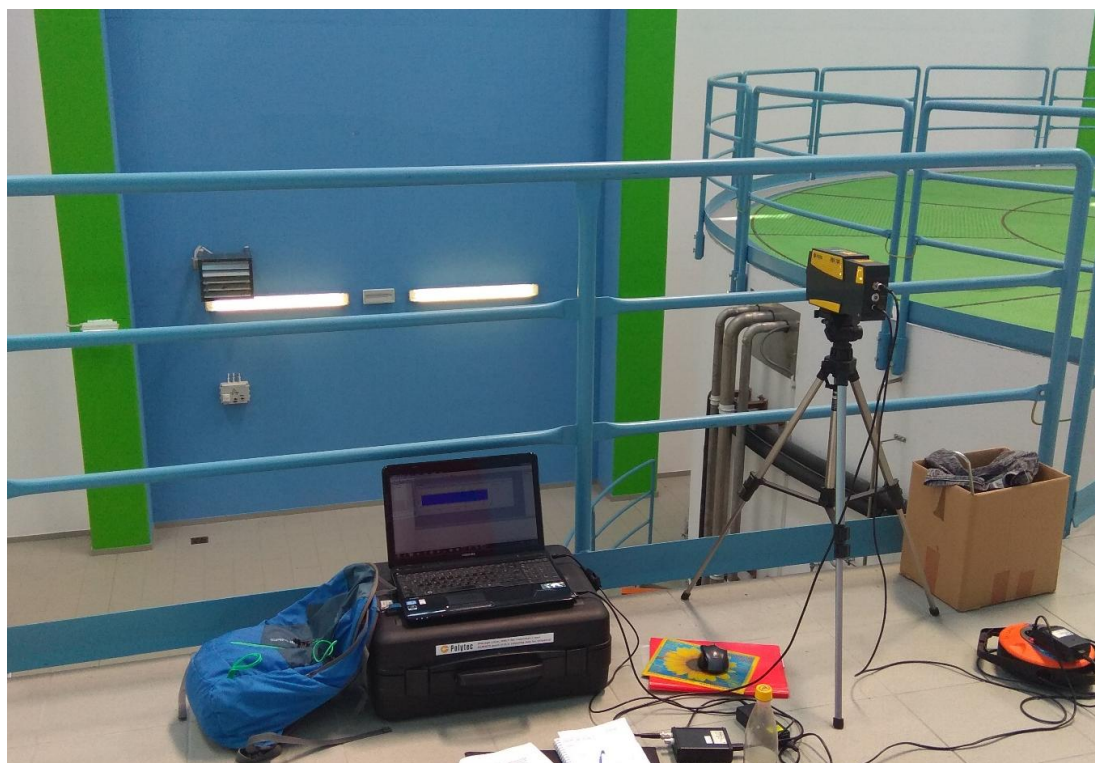
frequency shift of back scattered light from a moving surface. One of the main advantages of the vibrometer is that the device is portable and easy to use. Once we establish visible contact with the vibrating surface on the distance of maximum 30 m, the recording can begin [2,3]. One example of a measurement of HPP is presented in Figure 2.

Figure 2: Example of a measurement with the Laser Doppler Vibrometer

Laser Doppler Vibrometer is used for non-contact measurements of surface vibration velocities in the frequency range between 0 and 22 kHz. The device is an optical transducer, it works on the basis of optical interference and Doppler effect, it detects the
