Predrag L. Popovic

Senior Principal and Vice President
Wiss, Janney, Elstner Associates, Inc.
Northbrook, Illinois, USA
ppopovic@wje.com

AVOIDING MISTAKES DURING ASSESSMENT, DESIGN AND CONSTRUCTION OF STRUCTURAL REPAIRS

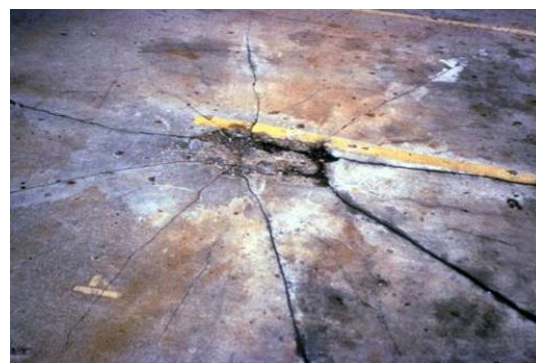
Figure 1. Severely cracked concrete slab

Sometimes we overact when we observe significant cracking in concrete structures like the one shown in Figure 1. Before we declare an emergency and start installing temporary shoring, we should perform a simplified quick evaluation of the remaining structural capacity. In some instances, we will find that even though structural capacity is reduced and strengthening is required, there may be enough capacity remaining. This condition need not be treated as an emergency.

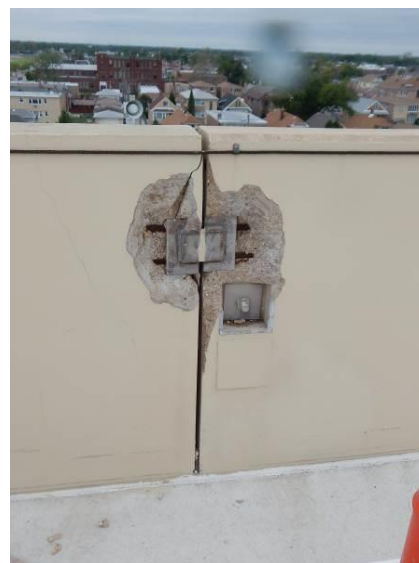
Figure 2. Cracking due to restrained volume change

It is not uncommon to misinterpret the structural distress caused by the restrained volume changes in concrete structures as shown in Figure 2. We should be aware that long pieces of concrete, when restrained at both ends, will crack because there will be large tensile stresses due to shrinkage and creep that can overcome the strength of the structural member. It is important to properly assess the cause of this distress in order to design appropriate repairs.

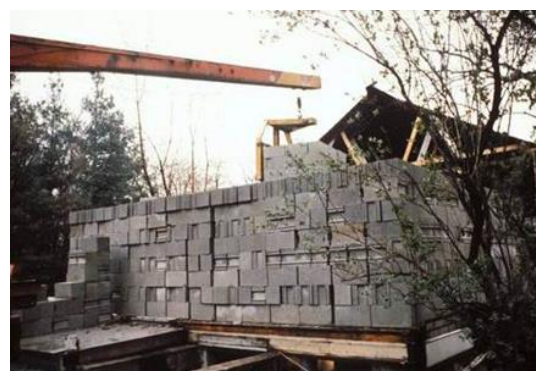
Figure 3. Arching of the test load

During the load testing of the structures, we have to recognize the effects of the possible arching of the test loads (Figure 3), the temperature effects on the structure during the testing (Figure 4) and the deflection of the loaded structure member under constant hydraulic load (Figure 5). We also need to design the test load application so it does not fail during the load application and that we provide adequate shoring under the structure in case of its unexpected failure under the test load (Figure 6).

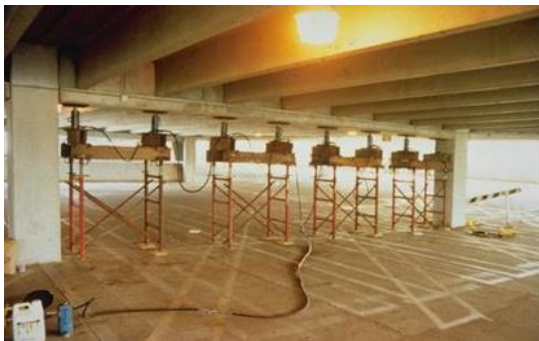
Figure 5. Hydraulic test loading

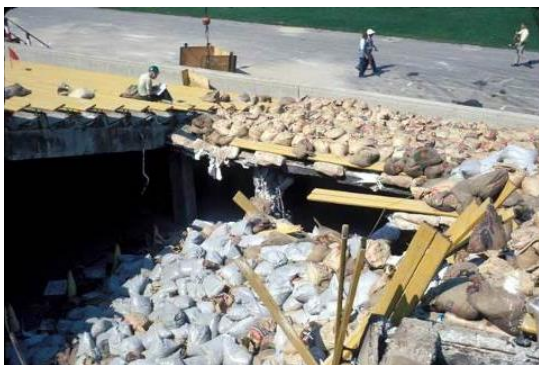
Figure 6. Failure of structure during the load test

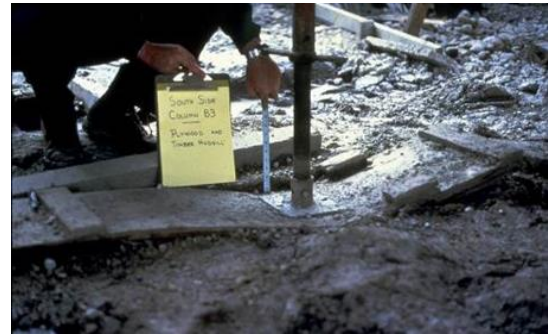
Figure 7. Deflection of shoring mudsill

enough to carry all vertical and lateral loads on the structure in addition to its self-weight. The footing elements of the shoring have to have adequate stiffness (Figure 7) to distribute the loads to the soil and to be properly designed for the expected soil reactions (Figure 8). Also, not taking into account temporary longitudinal loads may result in failure of the temporary shoring structure (Figure 9).

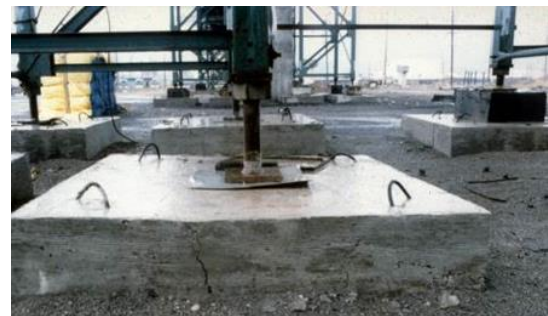
Figure 8. Cracked concrete bearing pad

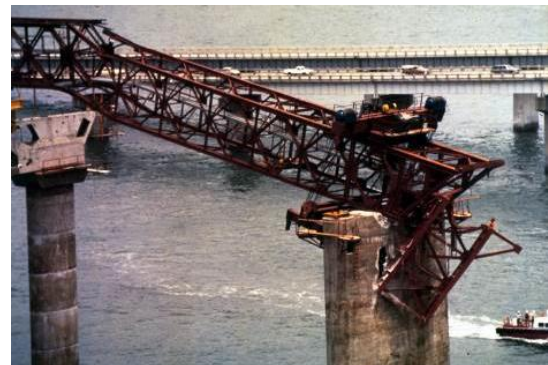
Figure 9. Collapsed construction gantry

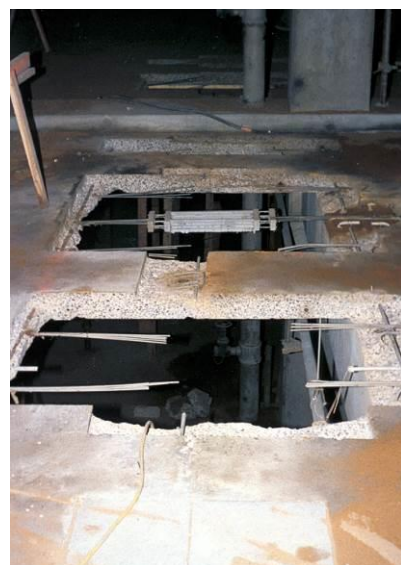
Figure 15. Compression struts in post-tensioning repairs

Similar conditions may occur in sequencing of repairs of post-tensioning tendons. If we do not provide for leaving concrete compression struts along the line of tendon repairs, parts of the structure may move when the tensioning loads are applied to the tendon (Figure 15).

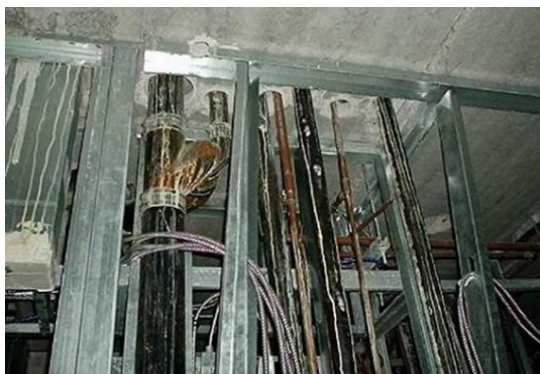
Figure 17. Closely spaced slab penetrations

When we need to design penetrations in the existing floor slabs, we need to make sure that they do not reduce the capacity of the slab beyond what is required. If we cut large openings in the slab (Figure 16) which interrupt the flow of tensile forces in a two-way slab system without additional reinforcing, the structure will not be able to carry even its self-weight. A similar condition may occur if we design too many penetrations in the floor close to each other (Figure 17).

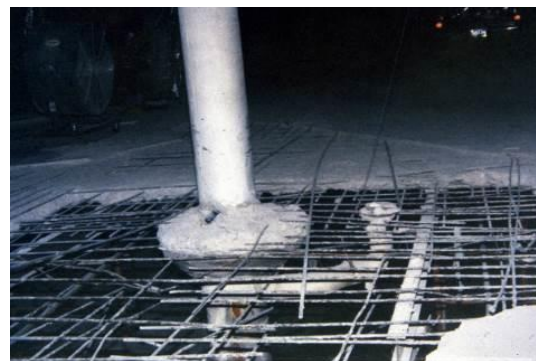
Figure 19. Removing concrete around column

Also, when we chip deteriorated concrete in slab around a column, the unbraced length of column doubles and it needs to be laterally supported (Figure 19).

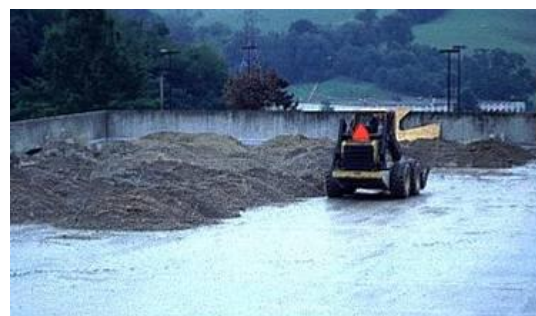
Figure 20. Excessive construction loads

We have to provide for additional supports to accommodate the weight of construction loads, including heavy equipment and removed debris to prevent overloading of the structure during repair (Figure 20).

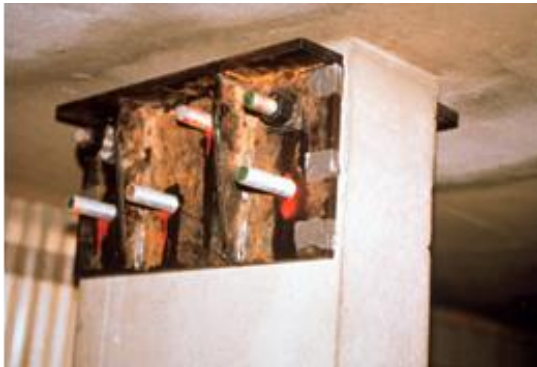
Figure 21. Irregular spacing of anchors

During the strengthening of the structures we oftentimes use steel anchors into the existing concrete to attach supplemental supports. It is very difficult to predict the exact as-built location of embedded steel reinforcing and we can have great difficulties placing the anchors in the

intended locations (Figure 21). It is important to allow for this condition by placing the anchors where possible and then drilling the holes in the attachments to match the locations of the already placed anchors.

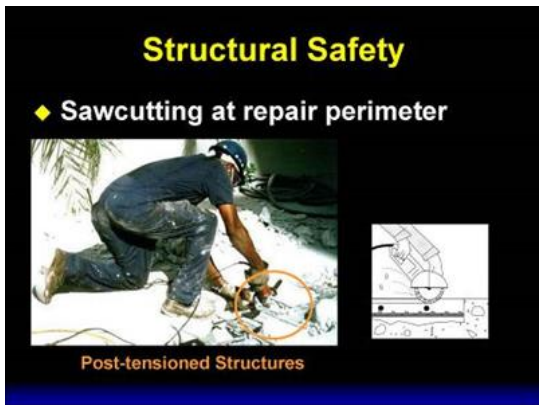
Figure 22. Cutting post-tensioning tendons

Special care is required during the repairs of post-tensioned concrete structures. Sometimes during the chipping of deteriorated concrete, the contractor may not be aware of the presence or location of post-tensioning cables and will cut them by mistake (Figure 22). It is important that the sequence of concrete removal does not result in undermining of the post-tensioning cable anchorages.

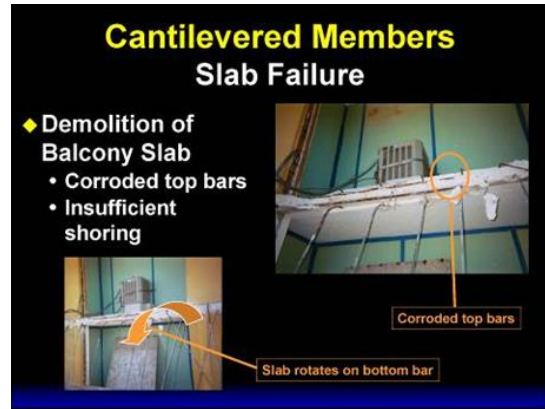
Figure 23. Balcony slab failure

The contractor should be aware how the structure is constructed and how its load-bearing elements function prior to beginning the repair. The main steel reinforcing is usually at the bottom of the concrete slab but it is the opposite in cantilevered balcony slabs. If that is not recognized in advance, concrete removal may result in collapse of the balcony (Figure 23).

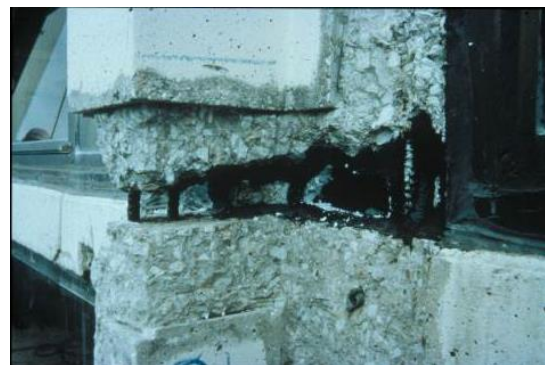
Figure 25. Excessive concrete excavation

When repairing a loaded concrete column, we need to be aware that chipping inside the reinforced column core, we will be removing loaded concrete and overstressing the column (Figure 24). It is also important that personnel in the field do not over excavate the concrete in loaded columns (Figure 25).

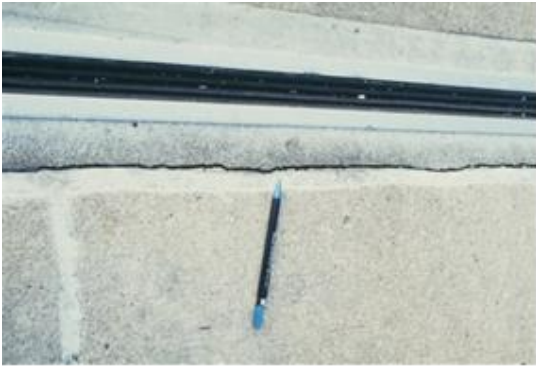
Figure 26. Failed joint seal

During concrete repairs, it is important that supplemental reinforcing steel be placed within required tolerances because even small variations may reduce the effectiveness of the repair. All repair materials are not always suitable for all repair applications. The repair material has to have similar characteristics to the base material including strength, modulus of elasticity and shrinkage. Otherwise, the repair will fail. It is common that concrete patches made with very high strength material with a lot of cement will crack because of large shrinkage. An example of improper material used for replacement of an expansion joint seal is shown in Figure 26.

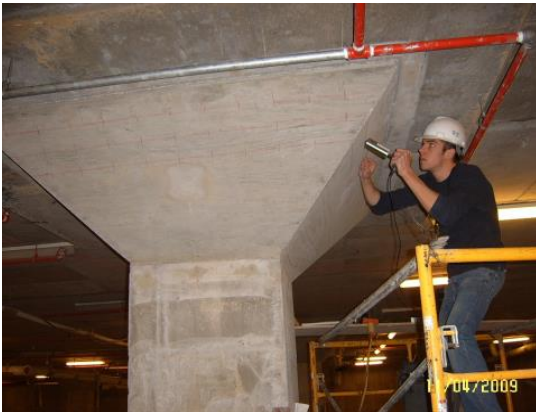
Figure 27. Testing for voids

When using an epoxy to inject cracks, it is necessary to confirm with tests that the epoxy has penetrated the full depth and length of the crack or an area to be epoxied (Figure 27). In concrete repair, proper surface preparation will ensure intimate bond between the patch material and the substrate. When the repair project includes installation of a protective waterproofing membrane over the repaired area, the ambient temperature and the temperature of the substrate have to be within the limits specified by the manufacturer to avoid failures of the membrane (Figure 28).
