THE PAVEMENT MANAGEMENT SYSTEM ON CROATIAN MOTORWAYS - EXAMPLE FROM PRACTICE

The pavement management system, as an integral part of the RoNeAna- Road Network Analyser of the Croatian Road Asset Management System, is implemented in managing pavements on Croatian motorways. This paper provides a brief overview (using the example of the A3 motorway) of pavement management procedures, from the collection of basic network and pavement construction data, to data processing aimed at determining performance indicators, to predicting the future behaviour of pavement, the required repair treatments with lists of priorities and expected costs, and various scenarios for multiannual maintenance planning. The condition of the A3 motorway, the most loaded highway in Croatia covering 300 km from the Slovenian to the Serbian border, is completely identified by visual inspection (cracking and surface defects) and other measured parameters (longitudinal and transverse evenness, skid resistance, macro-texture and bearing capacity).

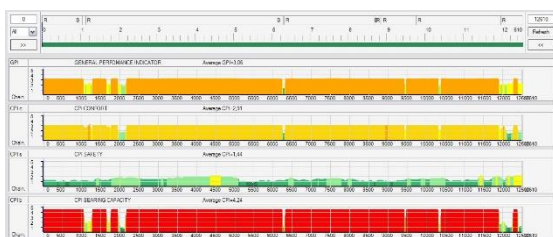
Figure 2. Performance indicators for the section Velika Kapanica-Babina Greda (left pavement, right lane)

After processing the results of the inspections and measurements, the management system calculates individual, combined and general performance indicators. The performance indicators are continuously calculated every 10 m, individually for each traffic lane. The results are shown in tabular and graphic form for each lane of pavement. Figure 2 shows the performance indicators for the driving lane on the left pavement of the section Velika Kapanica - Babina Greda (listed as Section 7. Velika Kapanica-Županja in Table 1). The critical technical parameters for this section are the cracks and the macro-texture. Medium severity alligator cracking determines pavement bearing capacity as very poor, and the general performance indicator as poor. Cracks have the greatest influence on the indicator of pavement bearing capacity, which is within the limits of the very poor condition ratings. The performance indicators for the driving lane of that section are shown in Table 4.

No	From [km]	To [km]	CPI _c	CPI _s	CPI _b	GPI
7.1	250.1	263.7	2.86	1.54	4.16	3.03

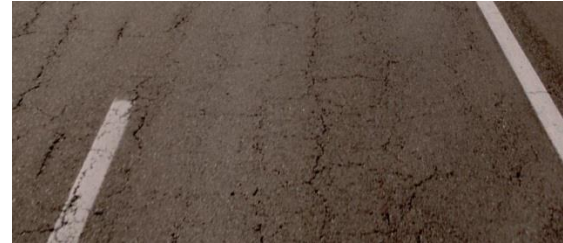
Figure 3. Alligator cracking on the section Velika Kapanica- Babina Greda (left pavement)

The state of this section surface layer is shown on Figure 3.

indicators and requiring the same kind of repair. Input data for determining homogeneous sections are a combination of technical parameters on the defined part of the pavement lane. Figure 3 shows the state of the surface layer of this section.

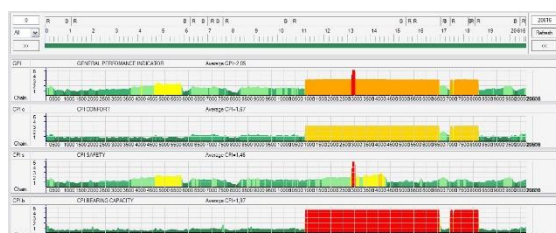
Figure 8. Performance indicators for the section Slavonski Brod-Velika Kopanica (left pavement, right lane)

This part of the A3 motorway has an overall good condition according to all performance indicators, though unlike the section of the motorway in paragraph 5.3, it has some parts with extremely poor condition. This primarily refers to the left pavement (direction towards the border with Serbia). The greatest influence on the performance indicators of the left pavement are cracks, mostly alligator cracks of low and medium intensity. The performance indicators of the characteristic section on that part (Slavonski Brod east-Sredanci, right driving lane of the left pavement) are shown in Figure 8.

Homogenous sections with estimated repairs depend primarily on the type and quantity of cracks. For homogenous sections with alligator cracks of medium intensity which, corrected with weighting influences, extend over 20% of the surface area, an analysis of the structure of the pavement and the reconstruction of layers is estimated. For the remainder of the homogenous sections with cracks of lesser intensity and quantity, repairs to the asphalt layers (from replacement of the final layer to larger repairs) are estimated. Those repairs cover both the poor condition of friction and the macro-texture.
