TRACK GEOMETRY DEGRADATION AND MAINTENANCE OF THE RAILWAYS

This paper studies track deterioration from geometric aspects and its influencing factors with a case study for railway line of pan – European Corridor 10 on the territory of North Macedonia.

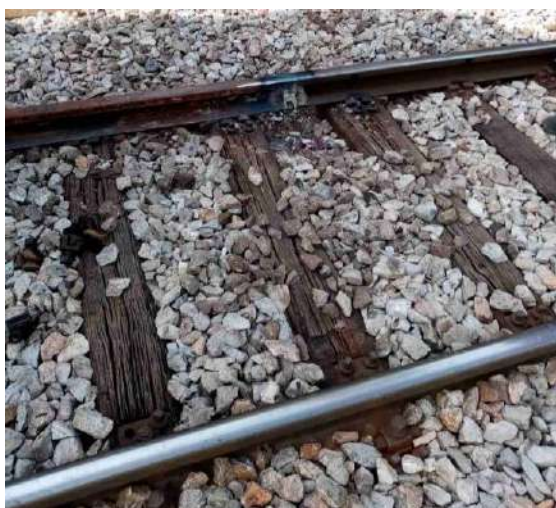
Figure 3. Superstructure with railway track of CWR
Source: Prospection in situ

The total railway track consists of continuous welded rails (CWR). The most used rail is S49 on 97,3% of track length and of 2,7% of rail length have rail type S54 (sections line between stations Tabanovci – Kumanovo and Romanovci – Miladinovci).

The timber is dominant with around 89% of total number of 329 727 sleepers on railway track of Corridor X. The normal sleeper spacing is between 600 - 650 mm.

The most wide - spread fastenings system on the track is rigid K-system for each section where the timber sleepers are set and elastic fastenings SKL-14 with greater elasticity in the case of prestressed concrete sleepers.

The ballast is constituted from crushed limestone with grading of 25/60 mm for sections between railway stations.

The thickness of the ballast bed is estimated 30 to 35 cm measured from the underside of the sleeper. The ballast is contaminated frequently by attrition of the ballast material or upwards penetration of fine particles in the form of a clay mixture or slurry.

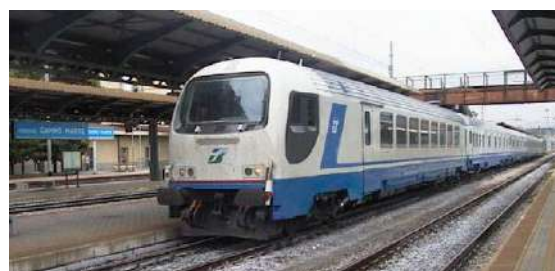
Figure 4. Mermec measuring vehicle

For measuring, recording and analysis of the track geometry, the standard equipment of every track recording car is the track geometry

measuring system. This consists of an inertial navigational measuring system with integrated GPS positioning and a dual optical gauge measuring system. Track geometry faults with wavelengths up to 200 m can be recorded, regardless of the measuring speed [8].

The track geometry measurements of the railways on the territory of North Macedonia were carried out by measuring vehicles of the company Mermec (Figure 4) in 2010 and 2013.

The system offers highly accurate measurements with real time reports of exceedances of allowed geometry.

The vehicle measures:

- track gauge - the distance between the inner surfaces of the head rails measured 14 mm lower than the head tops,
- cross level/cant - difference in the height of rail heads in one cross section,
- twist - difference in cant on the base length of 5 m,
- alignment (D1 and D2) - horizontal deviation of the rail head from a base line (10 m long) measured independently for both rails,
- longitudinal level (D1 and D2) - vertical deviation of the rail from a base line made by points of tangency of 2 wheels with the rail (base distance equals to 10 m). It is measured independently for both rails.

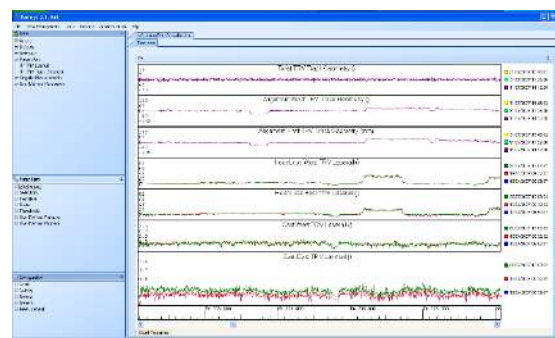
Figure 5. Measurement visualisation in Ramsys system

The Ramsys software system (Railway Asset Management System) developed by Mermec

interprets the raw data from track geometry measurements on a user-friendly module.

Figure 5 shows some of the visualization capabilities of the Ramsys system. The important thing here is the complete freedom of the user in terms of defining Views and customizing them to his/her own needs and liking, as well as freedom in combining various data types in any user-defined way in order to gain better insight into mutual dependencies between the data, correlations in order to search for the root cause of the problems.

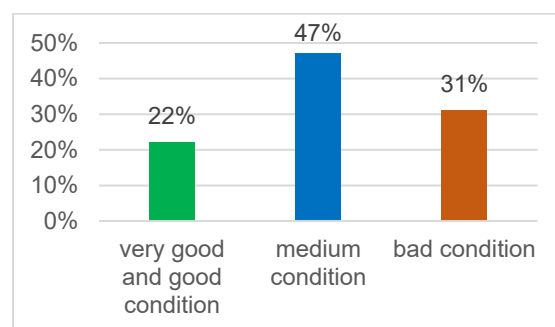
Figure 6. Condition of the railway Corridor 10 on the territory of North Macedonia

From the analyses data it is concluded that 22% of the railway network has been reported to be in very good and good condition, where approximately 70%-100% of designed speed can be achieved. The largest part of the railway network is in medium condition, with larger variations in the maximum allowed speed. On these sections, approximately 42%-88% of designed speed can be achieved. 31% of sections have been reported to be in a poor condition, where on average 55% of designed speed can be achieved (Figure 6).

At this moment, the railway can respond to the current traffic volume. However, the fact that only 11% of the railway from corridor 10, which passes through the Balkan countries, is classified as a favourable condition, while the

rest has medium or unfavourable conditions, indicates the need for reconstruction.
