## SEISMIC RETROFIT OF MASONRY WALLS USING REPOINTING

Seismic strengthening of masonry structures through repointing has been recognized as an efficient and low-cost technique for increasing structural stability, particularly in regions of high seismic activity. This paper shows the results from the research program that involved laboratory tests of the mechanical properties of masonry. The objective of the research was to evaluate the effectiveness of repointing as a method of strengthening existing structures, providing greater resistance to compression and dynamic loads.

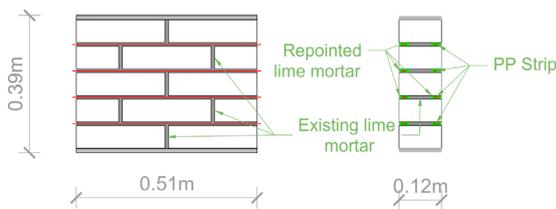
Figure 1. Horizontal application of PP strip and repointing.

- Strengthened masonry repointed with lime mortar and with horizontally placed polypropylene strips (Figure 1 and Figure 3).
- Strengthened masonry repointed with lime mortar and with diagonally placed polypropylene strips (Figure 2 and Figure 4).
- Strengthened masonry repointed with repair mortar FS4 and with horizontally placed polypropylene strips.

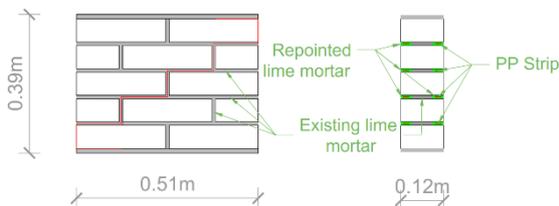
Figure 2. Diagonal application of PP strip and repointing

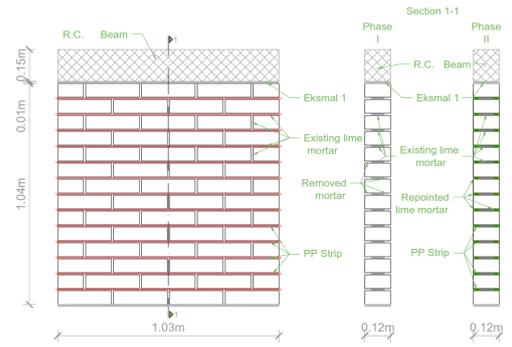
Figure 3. Horizontal application of PP strip and repointing.

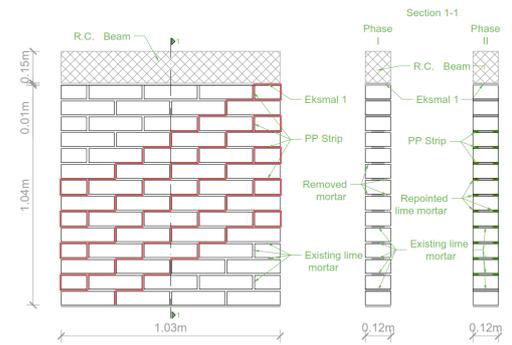
Figure 4. Diagonal application of PP strip and repointing.

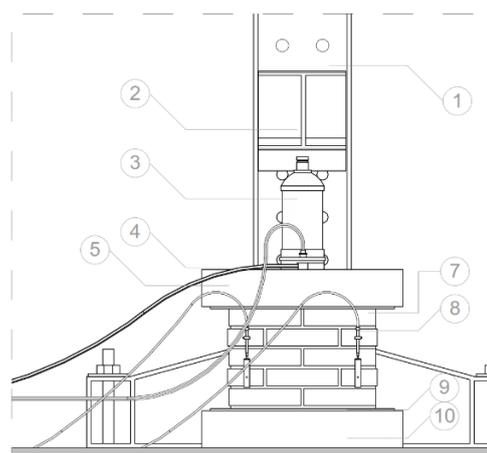
Testing of compressive strength was carried out by a special setup consisting of two metal columns (steel columns) fixed to a reinforced concrete floor by steel anchors, connected to an upper steel beam (steel beam "I 160") that served to provide stability and support to the hydraulic actuator. The testing wall was placed between the columns of the steel beam ("I 300") through a rubber layer with a thickness of 10 mm for better contact. Placed on the top of the wall was an additional rubber layer and a steel beam ("I 160") for transfer of the force to the load cell connected to the hydraulic actuator. This setup enabled precise measurements of compressive strength under strictly controlled laboratory conditions.

Figure 5. Setup for testing the compressive strength of masonry.

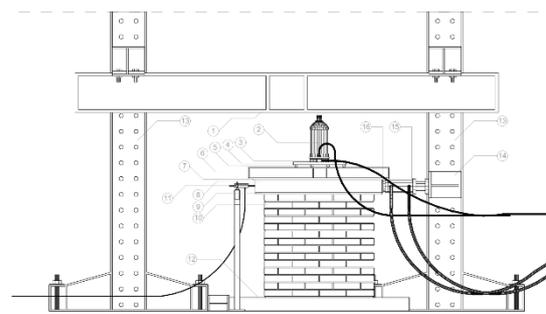
The setup for testing of shear strength consisted of four metal columns fixed to the reinforced-concrete floor, connected with steel beams. The walls were placed upon a steel beam ("I 200") and were stabilized with a reinforced concrete beam, whereas rubber layers with a thickness of 10 mm were used for better contact between the materials. Horizontal force was generated by the hydraulic actuator that transferred the force to the walls through roller bearings. A deflection meter (strain gauge) was placed for precise measurement of strains caused by horizontal loads.

Figure 6. Setup for testing of shear strength of masonry.

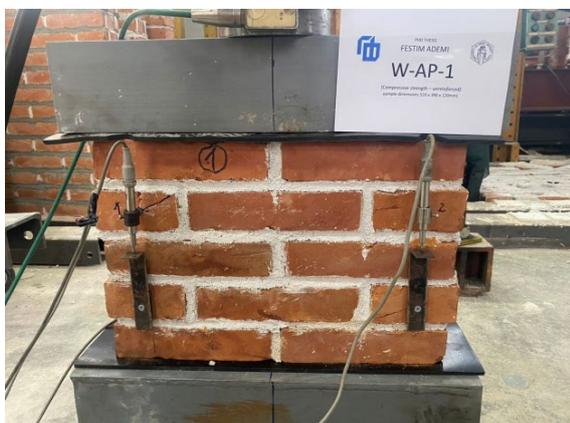
Within the frames of the investigation of the mechanical properties of masonry, several wall specimens were tested to define their compressive strength. The specimens were composed of 10 clayey bricks and mortar (lime mortar and repair mortar) that functioned as a composite material. The proportions of the bricks were 250 x 120 x 60 mm, whereas those of the walls were 510 x 390 x 120 mm. Tested were eight walls, distributed into four categories with two specimens each: unreinforced walls, walls strengthened with lime mortar and PP strip in horizontal joints, walls strengthened diagonally with a PP strip and walls strengthened with repair mortar FS 4 and PP strip in horizontal joints.

Figure 7. Testing the compressive strength of masonry.

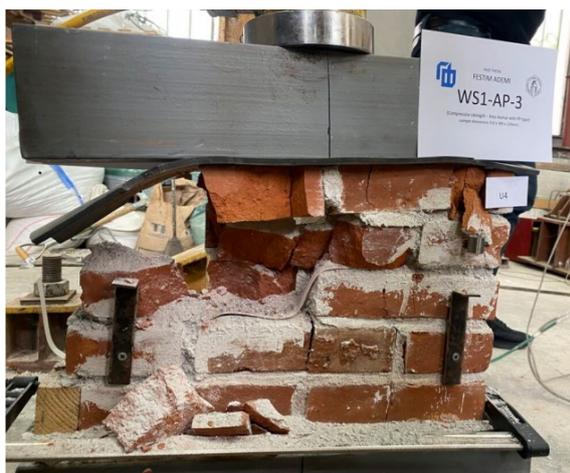
Figure 8. Compressive strength - a wall after testing (under the effect of compressive force).

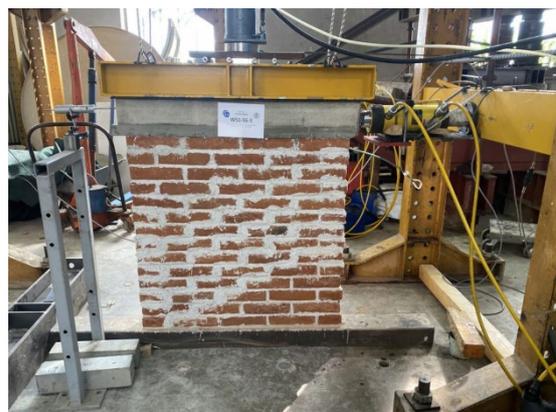
to the tests of compressive strength, tests of shear strength were also carried out. Each wall was composed of 56 clayey bricks and mortar (lime mortar or repair mortar) as a composite material. The proportions of the bricks were 250 x 120 x 60 mm, while those of the test specimens were 1030 x 1040 x 120 mm. Tested were a total of eight walls divided into four categories, with two specimens each: unreinforced walls, walls strengthened with lime mortar and PP strip in horizontal joints, walls strengthened diagonally with PP strip and walls strengthened with repair mortar FS4 and PP strip in horizontal joints.

Figure 9. Testing of shear strength of masonry.

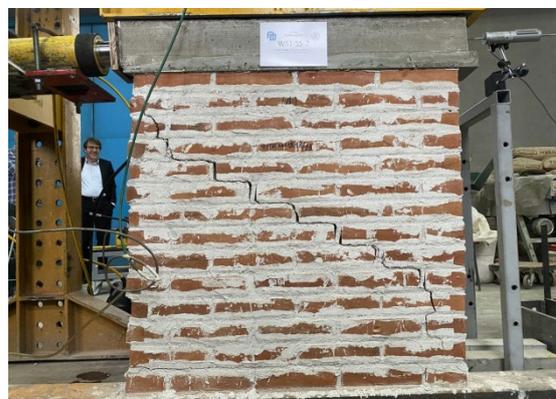
Figure 10. Shear strength - wall after testing.

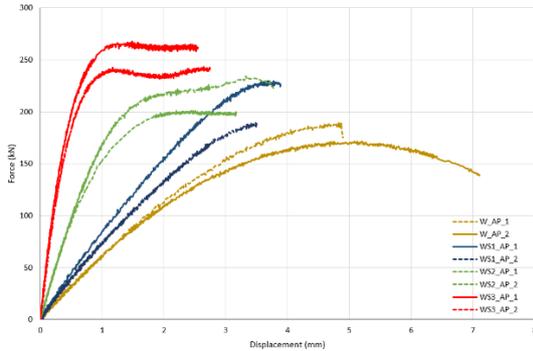
Figure 11. Force-deformation diagram for testing compressive strength of walls.

The tests showed important improvements in the strength of masonry structures by the application of different strengthening techniques [5]. WS1\_AP: Strengthening with lime mortar and PP strip in horizontal joints resulted in an increase of maximum strength of 16.1% and final strength of 31.9%, with a decrease of deformation of 27.6% and 38.5%. WS2\_AP: The diagonal position of the PP strip led to an increase of maximum strength of 20.6% and final strength of 34.1%, with a decrease of deformations of 42.5% and 41.9%. WS3\_AP: Strengthening with repair mortar and PP strip in horizontal joints showed the highest level of improvement, with an increase of maximum strength of 41.5% and final strength of 60.1%, whereas deformations were reduced for 58.9% and 55.9%. The data are presented in tabular form in Table 2.

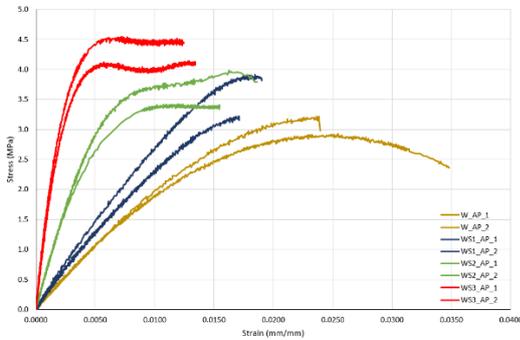
Figure 12. Stress-deformation diagram for testing compressive strength of walls.

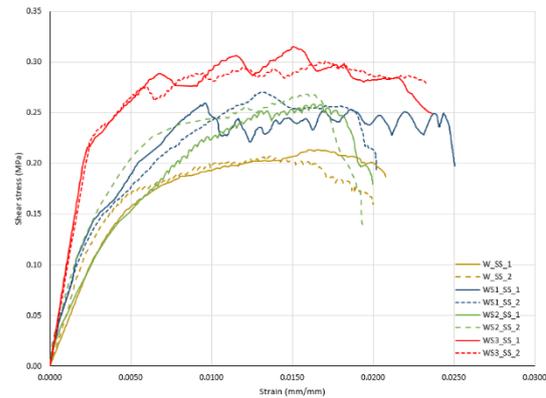
Figure 13. Shear stress - deformation diagram for different types of walls.

W\_SS\_1 and W\_SS\_2 unreinforced walls served as the basic line for comparison. They showed the lowest shear strength and the greatest deformation under loads. WS1\_SS\_1 and WS1\_SS\_2 were strengthened with lime mortar and a horizontally placed PP strip, which resulted in an increase of shear strength of about 25.9% and a decrease of deformation of 24.5% compared to unreinforced walls. WS2\_SS\_1 and WS2\_SS\_2 with a diagonally placed PP strip and lime mortar showed an increase of shear strength of 25.3% and a decrease of deformation of 6.3% compared to the basic specimens. WS3\_SS\_1 and WS3\_SS\_2, strengthened with repair mortar FS4 and horizontally placed PP strips showed the best results, with an increase of shear strength of 46.6% and a decrease of deformation of 6.1%.

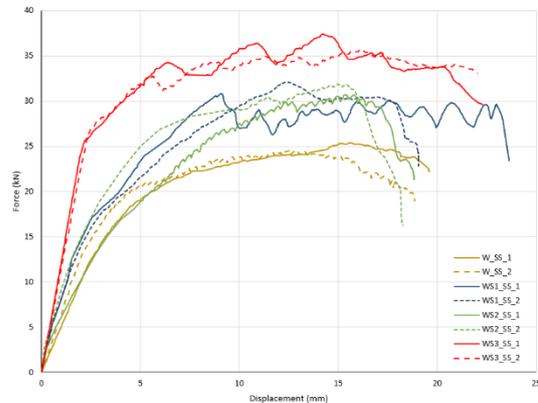
Figure 14. Force - displacement diagram for unreinforced walls and walls strengthened with different methodologies.
