Predrag L. Popovic

Senior Principal and Vice President
Wiss, Janney, Elstner Associates, Inc.
Northbrook, Illinois, USA
ppopovic@wje.com

ASSESSMENT AND REPAIR OF EXTERIOR FACADES

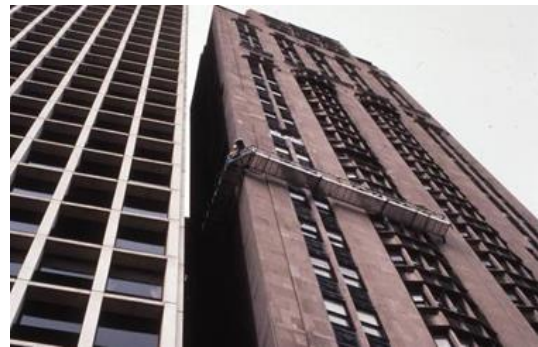
During the assessment of conditions and repair of exterior facades, access and personal safety were major issues. To access the facade, there is a need to install a suspended scaffold system which needs to be properly supported at the top of the building (Figures 3 and 4). In addition to the support, the scaffold needs to be tied to a different point at the building in case of failure

Figure 3. Suspended scaffolds on the side of the building

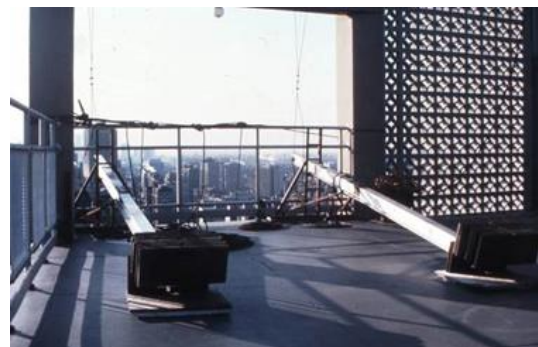
Figure 4. Supports for suspended scaffold
