AUTHORS

UPGRADING OF SEISMIC OSCULATION SYSTEMS ON "PIVA" DAM

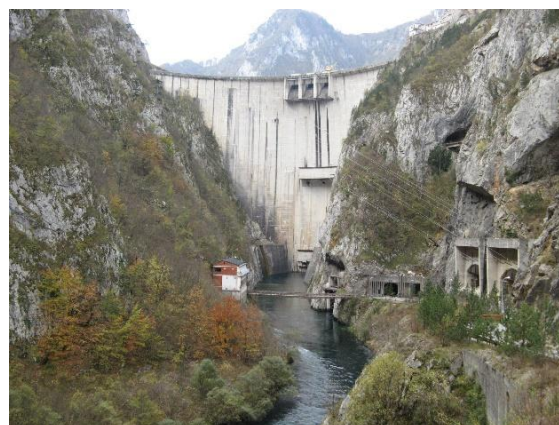
Figure 1. Dam "Piva"

HPP „Piva“ dam (i.e., „Mratinje“ dam) is among extremely high dams and among the 25 highest arch dams in the world (Fig.1). The stress and deformation state of the dam is dominantly affected by the reservoir level (hydrostatic pressure) and the temperature of the dam body. The rock massif at the dam location is composed of massive limestone originating from the Middle Triassic that was exposed to intensive tectonic motions. The structure of the damage in the form of cracks caused by these disturbances stretches in the direction that is approximately perpendicular to the river course, which is favourable from the aspect of safety against sliding. The cracks divide the rock mass into large blocks, but without crushed zones in their surrounding and are partially filled with clay and calcite. The size of the crack openings is reduced with depth so that they lose the characteristics of mechanical discontinuities. The mechanical characteristics of the rock massif at the sides

HPP „Piva“ dam represents concrete, asymmetric, arch dam with a double curvature (Fig. 1). Construction of this dam, created an artificial water reservoir used for production of electricity in the accompanying hydroelectric power plant „Piva“. The topographic, geological, geotechnical and geophysical documentation show that the dam profile is asymmetrical and has a pronounced „V“ shape meaning that HPP „Piva“ dam is a surface bearer with pronounced arch effect. The arch is asymmetrical and of variable thickness and curvature. The extrados and intrados of the arch are defined by the fragments of the circle, while the central line, i.e., the arch axis

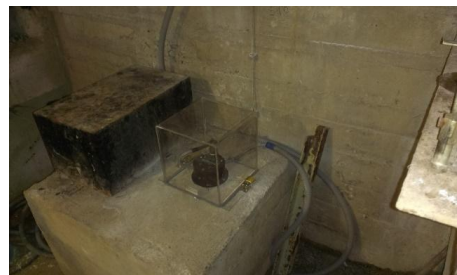
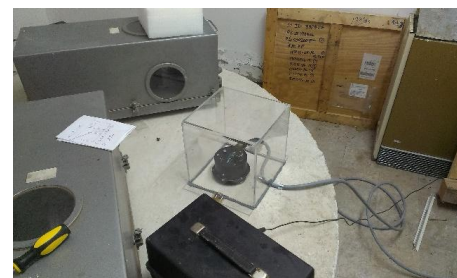
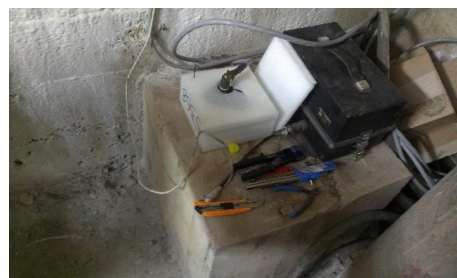
Figure 3. Installation of the seismic monitoring network

The modern, digital system for seismic osculation enables continuous and reliable monitoring of the seismic activity and recording of occurred earthquakes. In 2013, a modern digital seismic monitoring network was installed (Fig. 3). Eight digital episensors are installed, tree on the crest, four on different locations on the dam's body and one on bedrock in the occulation building. Instruments are placed so that the full height of the central console is instrumented. Central unit is providing recording in real time.
