Ljupcho Petkovski

PROPAGATION OF FLOOD WAVE CAUSED BY TAILINGS DAMS FAILURE

Keywords: flood wave, dams, tailings, failure, 2D analysis, HEC RAS

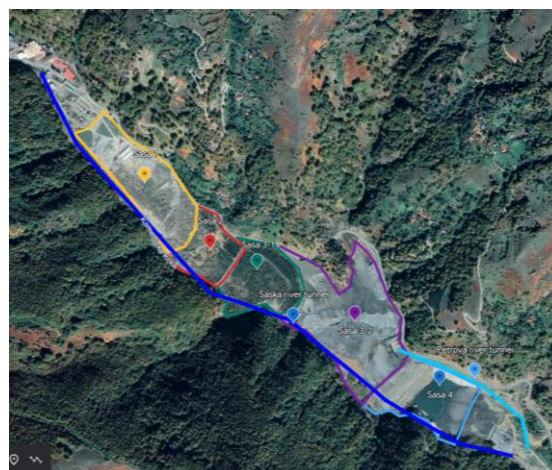
Figure 1. Layout configuration of all five TSFs in the zinc and lead mining complex 'Sasa'. The diversion tunnel for Saska river is under the right bank, whereas the tunnel for Petrova river is under the left bank. Source: Google Earth

Within the zinc and lead mining complex 'Sasa', located in the northeast part of RN Macedonia some 12km upstream from the city of Makedonska Kamenica, five cascade tailings storage facilities (TSFs) are formed: TSF Sasa 1 at 1035 masl, TSF Sasa 2 at 1015 masl, TSF Sasa 3-1 at 995 masl, TSF Sasa 3-2 at 978 masl and TSF Sasa 4 at 952 masl. The fifth TSF – TSF Sasa 4 – is currently in service period (Figure 1).

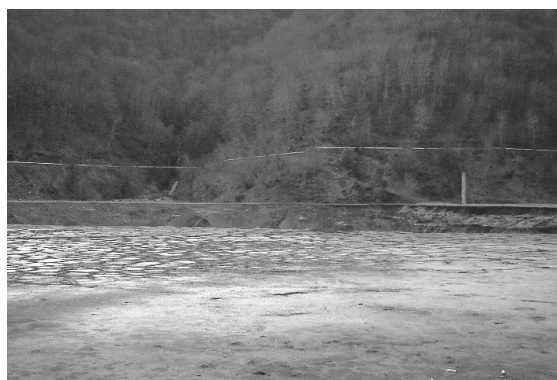
Figure 2. Picture of the visible part of the crater formed in the lagoon of Sasa 3-1

TSF Sasa 3-1 is no longer in service since 2003, when an accident occurred with the drainage system. During this accident, a large crater was formed in the waste lagoon Sasa 3-1 (Figure 2), and mudflow propagated downstream in the river valley. The height of the flow was around 10m, and the flood wave reached 12km in length. It is assumed that some 70 000 – 100 000 m³ of tailings was discharged in the river valley and subsequently in Kalimanci lake [4]. Today, two decades after the accident, downstream of TSF Sasa 3-1, the waste lagoon of Sasa 3-2 is located. It is assumed that the sand dam of Sasa 3-1 keeps the lagoon stable and the risk of mud propagation from Sasa 3-1 is minor [6].

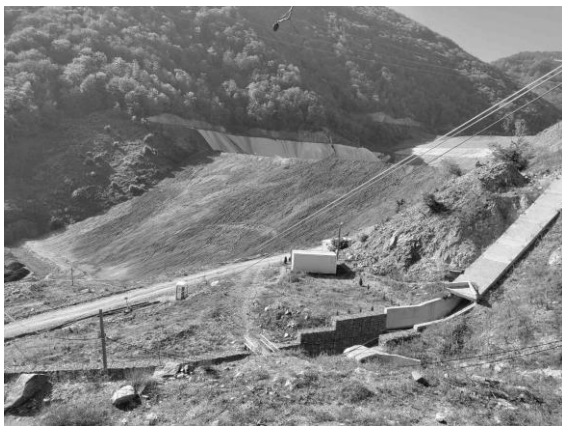
Figure 4. Downstream slope of tailings dam Sasa 4. Picture dates from October, 2022

Currently in operation stage is TSF Sasa 4, which is created with construction of a combined tailings dam, with crest elevation of 932.0 masl in October, 2022 (Figures 3 and 4). Designed crest elevation of the tailings dam Sasa 4 is 952.0 masl, with maximal waste lagoon elevation of 950.0 masl.

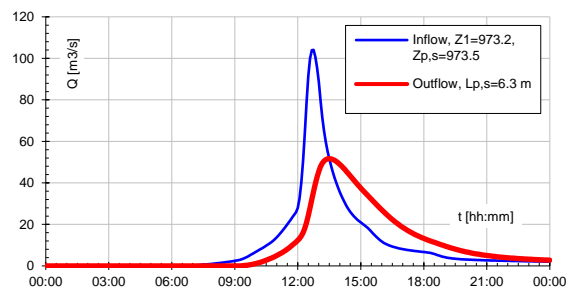
Figure 8. Hydrograph of flood wave for Petrova river, with recurrence interval of $T = 10\,000$ years, inflow and outflow hydrograph

It should be noted that Saska river is completely diverted from the tailing facility location, and its flood wave (Figure 7) is expected to have effect in the riverbed downstream of the TSF Sasa 4, hereinafter it does not contribute to the rainfall – runoff input for any of the scenarios. Its hydrograph is entered as a boundary condition downstream of Sasa 4, and its influence increases the total flood wave effect in the downstream valley, however, it does not have effect on the dams’ failure. On the other hand, the tributary of Saska river – river Petrova, enters the reservoir of TSF Sasa 3-2. For evacuation of the expected flood wave (Figure 8), a spillway with tunnel structure is designed in TSF Sasa 3-2 (Figure 9).

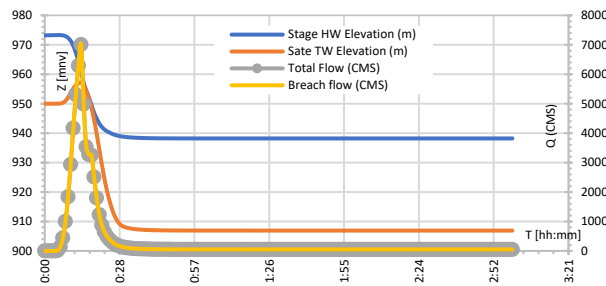
Figure 11. Hydrograph of water level and flood wave in the profile of TSF Sasa 3-2, for scenario 1

For scenario 1 (Figures 11 and 12), the maximal flow expected as breach flow at TSF Sasa 3-2 is $Q_{max} = 7006 \text{ m}^3/\text{s}$, whereas at TSF Sasa 4 it is $Q_{max} = 6652 \text{ m}^3/\text{s}$. The total breach flow at TSF Sasa 4 is $Q = 7475 \text{ m}^3/\text{s}$. As the breach progresses downstream, combined with the flood wave of Petrova river and Saska river, its maximal value just downstream of TSF Sasa 4 is $Q = 7609 \text{ m}^3/\text{s}$. The time difference

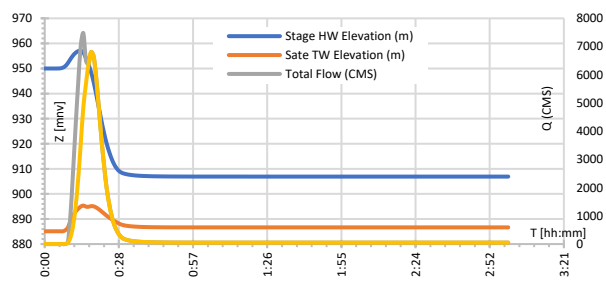
Figure 12. Hydrograph of water level and flood wave in the profile of TSF Sasa 3-2, for scenario 2

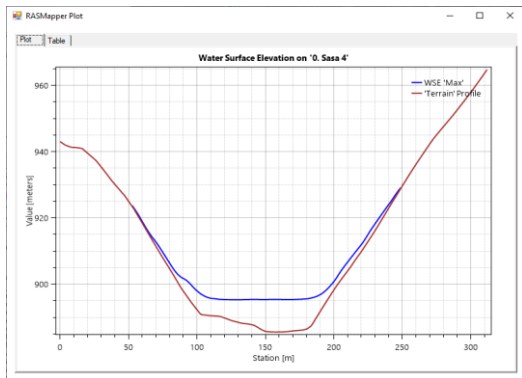
Figure 14. Water surface level at profile 00 – downstream of TSF Sasa 4, for scenario 1

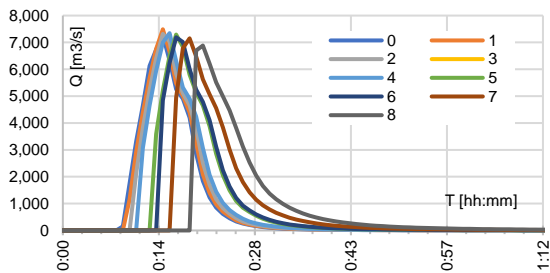
Figure 16. Hydrographs of flood wave propagation for profiles 0 – 9, for scenario 1

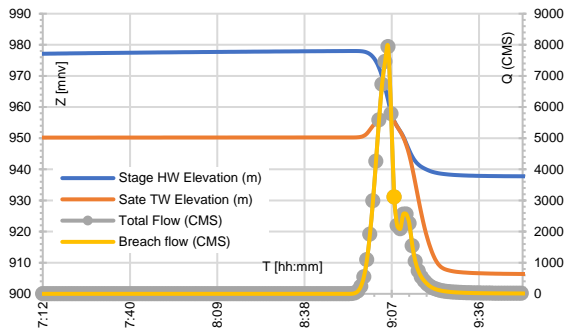
Figure 19. Hydrograph of water level and flood wave in the profile of TSF Sasa 3-2, for scenario 2

For scenario 2 (Figures 19 and 20), the maximal flow expected as breach flow at TSF Sasa 3-2 is $Q_{max} = 7458 \text{ m}^3/\text{s}$, whereas at TSF Sasa 4 it is $Q_{max} = 5684 \text{ m}^3/\text{s}$. The total breach flow at TSF Sasa 4 is $Q = 7716 \text{ m}^3/\text{s}$. As the breach progresses downstream, combined with the flood wave of Petrova reka, its maximal value just downstream of TSF Sasa 4 is $Q = 8271 \text{ m}^3/\text{s}$. The time difference between dam breaching of Sasa 3-2 and Sasa 4 is 5min.

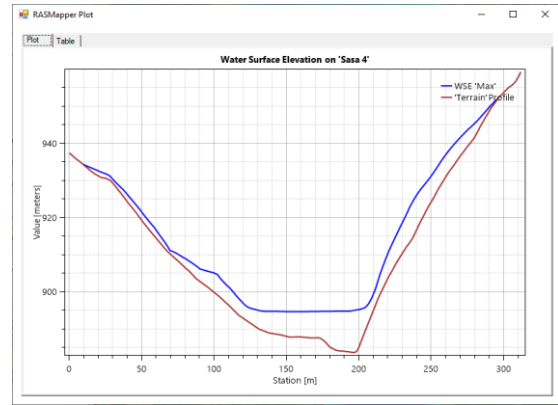
Figure 21. Water surface level at profile 00 – downstream of TSF Sasa 4, for scenario 2
