## **PROPAGATION OF FLOOD WAVE CAUSED BY TAILINGS DAMS FAILURE**

Keywords: flood wave, dams, tailings, failure, 2D analysis, HEC RAS

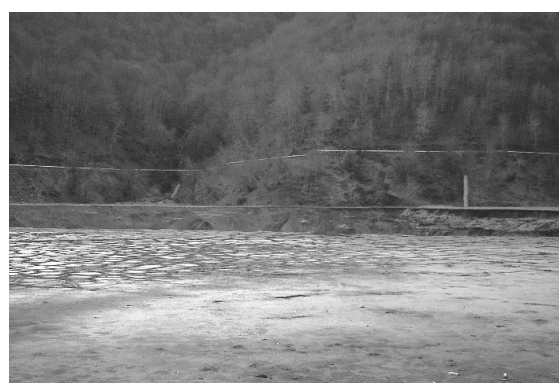
Figure 2. Picture of the visible part of the crater formed in the lagoon of Sasa 3-1

TSF Sasa 3-1 is no longer in service since 2003, when an accident occurred with the drainage system. During this accident, a large crater was formed in the waste lagoon Sasa 3-1 (Figure 2), and mudflow propagated downstream in the river valley. The height of the flow was around 10m, and the flood wave reached 12km in length. It is assumed that some 70 000 – 100 000 m<sup>3</sup> of tailings was discharged in the river valley and subsequently in Kalimanci lake [4]. Today, two decades after the accident, downstream of TSF Sasa 3-1, the waste lagoon of Sasa 3-2 is located. It is assumed that the sand dam of Sasa 3-1 keeps the lagoon stable and the risk of mud propagation from Sasa 3-1 is minor [6].

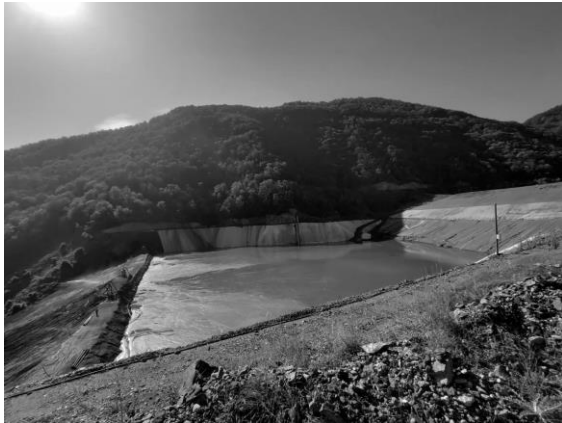
Figure 3. Downstream tailings dam Sasa 4, waste lagoon of Sasa 4, and upstream tailings dam Sasa 3-2. Picture dates from October, 2022

Currently in operation stage is TSF Sasa 4, which is created with construction of a combined tailings dam, with crest elevation of 932.0 masl in October, 2022 (Figures 3 and 4). Designed crest elevation of the tailings dam Sasa 4 is 952.0 masl, with maximal waste lagoon elevation of 950.0 masl.

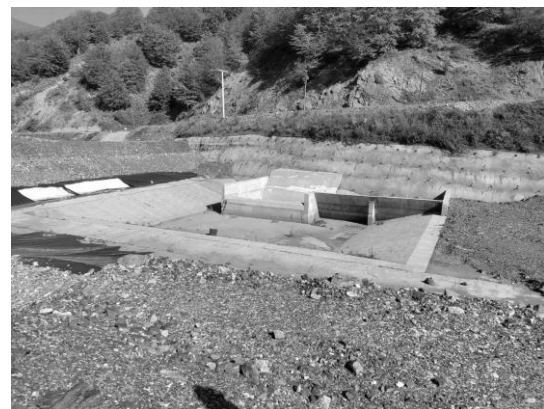
Figure 9. Spillway structure in TSF Sasa 3-2 for evacuation of flood wave from Petrova river

It should be noted that Saska river is completely diverted from the tailing facility location, and its flood wave (Figure 7) is expected to have effect in the riverbed downstream of the TSF Sasa 4, hereinafter it does not contribute to the rainfall – runoff input for any of the scenarios. Its hydrograph is entered as a boundary condition downstream of Sasa 4, and its influence increases the total flood wave effect in the downstream valley, however, it does not have effect on the dams’ failure. On the other hand, the tributary of Saska river – river Petrova, enters the reservoir of TSF Sasa 3-2. For evacuation of the expected flood wave (Figure 8), a spillway with tunnel structure is designed in TSF Sasa 3-2 (Figure 9).

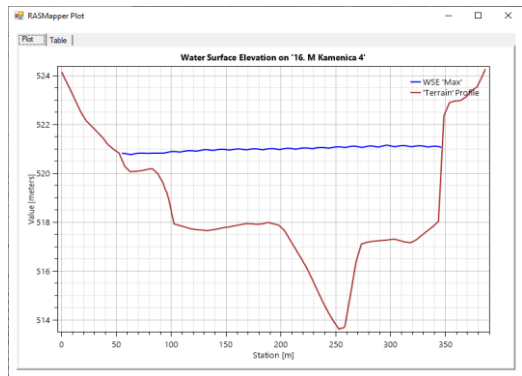
Figure 15. Water surface level at profile 16 – in the city of Makedonska Kamenica, for scenario 1

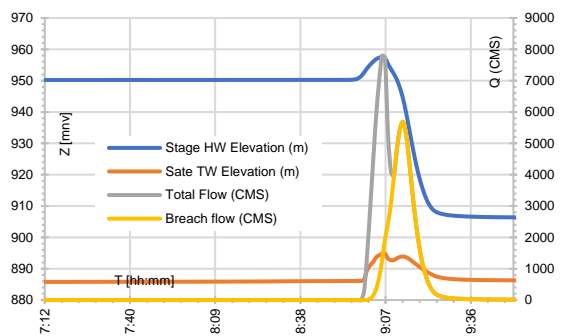
Figure 20. Hydrograph of water level and flood wave in the profile of TSF Sasa 4, for scenario 2

For scenario 2 (Figures 19 and 20), the maximal flow expected as breach flow at TSF Sasa 3-2 is  $Q_{max} = 7458 \text{ m}^3/\text{s}$ , whereas at TSF Sasa 4 it is  $Q_{max} = 5684 \text{ m}^3/\text{s}$ . The total breach flow at TSF Sasa 4 is  $Q = 7716 \text{ m}^3/\text{s}$ . As the breach progresses downstream, combined with the flood wave of Petrova reka, its maximal value just downstream of TSF Sasa 4 is  $Q = 8271 \text{ m}^3/\text{s}$ . The time difference between dam breaching of Sasa 3-2 and Sasa 4 is 5min.

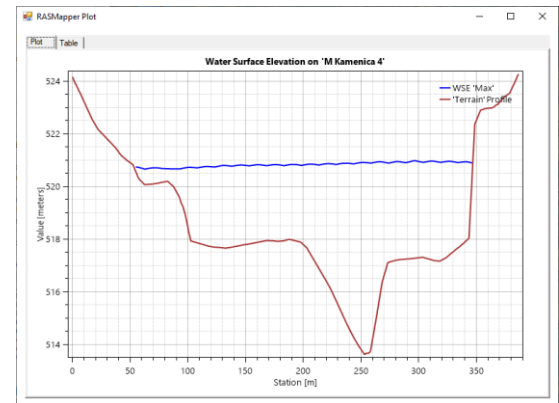
Figure 22. Water surface level at profile 16 – in the city of Makedonska Kamenica, for scenario 2

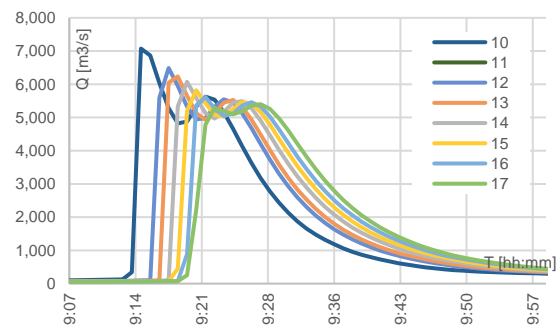
Figure 24. Hydrographs of flood wave propagation for profiles 10 – 17, for scenario 2
