## **ENVIRONMENTAL INFLUENCES ON BRIDGES: AN ASSESSMENT STUDY**

**Keywords:** ambient vibration measurements, dynamic characteristics, reinforced concrete bridges, condition assessment

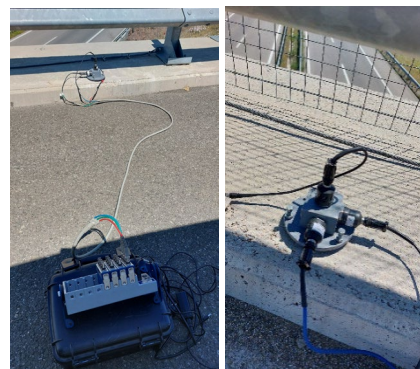
Figure 1. Field monitoring equipment (left), three-way accelerometer (right)

PCB Piezotronics devices, model 393B12, manufactured by National Instruments with a sensitivity of 10,000 mV and a range of up to 4.9 m/sec<sup>2</sup>, with a size of 0.5g were used. Data acquisition was performed with the acquisition system - module NI cDAQ-9178 and 4 NI 9234 boards (Fig. 1). The recorded acceleration measurements are expressed in "Earth acceleration - g" (9.81 m/sec<sup>2</sup>).

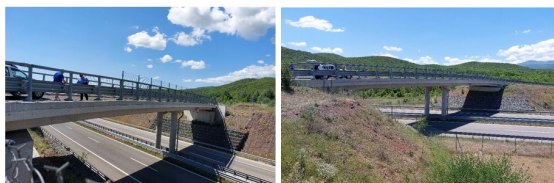
Figure 2. Measured structures OP2 and OP3

Withing the framework of this research, field measurements of two overpasses (OP2 and OP3, Fig. 2) were carried out. The selected bridges are located over the "Friendship" highway, Demir Kapija - Gevgelija section, designed according to modern regulations that consider the seismic action. Both overpasses are with 2 spans each of which 23 m. The selected bridges are designed according to modern regulations that consider the seismic action. The initial measurements of the structures were carried out in October 2017,

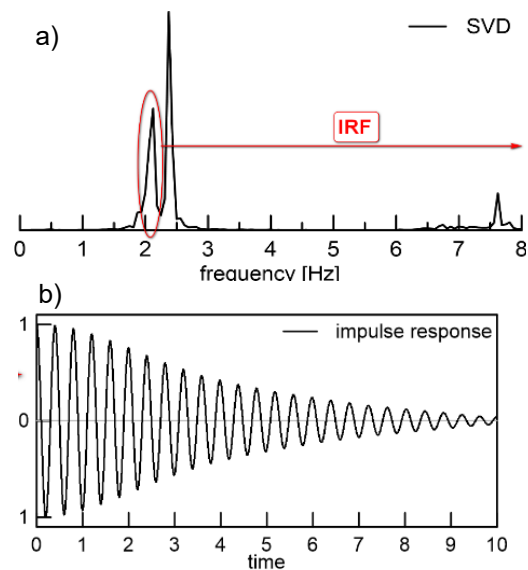
Figure 4. FDD method, estimation of the modal damping ratio

Enhanced Frequency Domain Decomposition was performed in order to calculate the damping (IRF) by using the impulse response of a single degree of freedom. Once a set of points with similar singular vectors is selected for a particular mode (Fig. 4a), this segment of an auto-spectrum may be converted to a time domain (Fig. 4b).

An auto-correlation function with the contribution of a single mode is obtained. As the output correlation of a dynamic system excited by white noise is proportional to its impulse response, it is possible to estimate the modal damping coefficient. This can simply be performed by fitting an exponential function to the relative maxima of the correlation function and extracting the modal damping ratios from the parameters of the fitted expression taking into account the classical expression for the

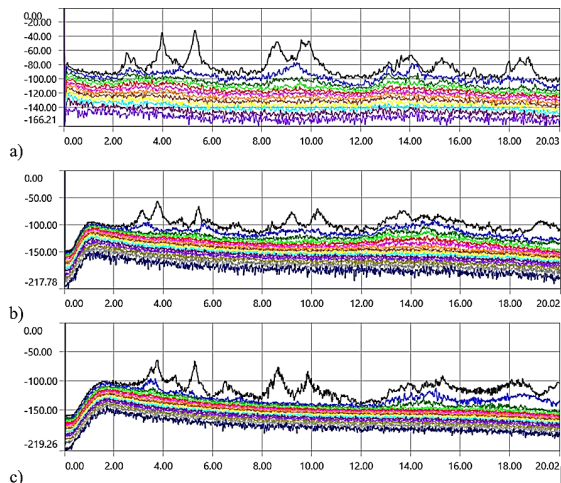
Figure 7. Singular value of spectral densities for OP3 a) 2017, b) 2020, c) 2022

registrations and their singular value of spectral densities, a certain amount of data on the dynamic characteristics of the investigated structures were obtained. Below, on Fig. 7 the curves of singular value of spectral densities for OP3 are presented.
